## AVIATION INVESTIGATION REPORT A02A0065

### SEAT FAILURE AND LOSS OF CONTROL

BLUENOSE SOARING CLUB  
SCHEMPP-HIRTH KG CIRRUS (GLIDER) C-GUIL  
STANLEY AIRPORT, NOVA SCOTIA  
21 MAY 2002

Report Number A02A0065

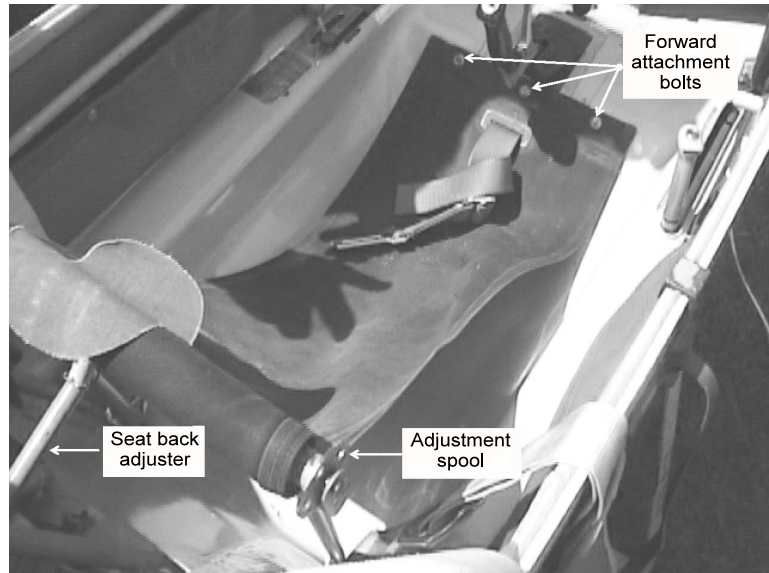
The seat is a slung cloth hammock (See Figure 1 - Seat Assembly). The front attachment, under the pilot's legs, is secured to the floor by three bolts, and is not adjustable. The aft attachment, behind the pilot's shoulders, is a spool attached to a movable seat frame. The spool allows the pilot to vary the number of material wraps, and provides height adjustment. The seat back frame adjusts fore and aft to move the pilot's body fore or aft. Adjustment is accomplished by selecting the appropriate hole in the spring loaded lever and aligning it with a stationary pin attached to the airframe structure. In the most forward position, the pilot is in a semi-reclined seating position; the further rearward the selection, the more reclined the upper torso of the occupant. Examination of the glider seat assembly did not establish the exact position of seat adjustment at impact. After the accident, the right and centre attachment bolts were found to have pulled out of their anchor nuts, the bolts remaining within the seat fabric and aluminum attachment strip. The left bolt was still in its anchor nut, but was only finger tight.

The seat assembly and the airframe anchor nuts were removed and sent to the TSB Engineering Branch for examination to determine the thread condition of the bolts and anchor nuts. There was no indication of excessive wear, deformation, or other damage to the threads of the bolts. The threads on the right and the centre anchor nuts indicated that they had been previously cross-threaded, resulting in significant damage. The first four threads of the right anchor nut had a shinier surface appearance than the remainder of the threads in that anchor nut. It was not possible to quantify the extent to which this thread damage reduced the clamping strength of the anchor nuts. It could not be determined, through engineering analysis of the seat and attachment hardware, whether the bolts pulled out prior to ground impact or as a result of ground impact loads.

Figure 1 - Seat assembly from an intact Cirrus glider

During the accident launch, acceleration forces would have effectively pressed the pilot rearward, transferring high load forces to the seat and its attachment hardware. Two of the three forward seat attachment bolts were found detached. The shiny appearance of the threads on the right anchor nut was likely due to the bolt tearing out, which would suggest that the bolt in the right anchor nut was only engaged by a maximum of four threads. Ordinarily, this amount of thread engagement would be sufficient to provide the maximum strength of the bolt and anchor nut assembly. However, in this occurrence, the threads had been previously damaged by cross-threading, and the assembly may not have been able to develop the full clamping force. It could not be determined why the bolts were not completely fastened.

1. The combined effect of the cross-threading damage, the probability that the centre and right bolts were not fully engaged, and the acceleration forces of the launch resulted in the bolts pulling free from the anchor nuts, resulting in seat failure.
2. The pilot lost control of the glider when the seat failed.
